SERVICE BULLETIN

SB023-1094

Subject: Nose Gear Door
Date: 12th October, 1994
Ref: Manual Page: 20-37
Pages: 1
Status: Changes Recommended

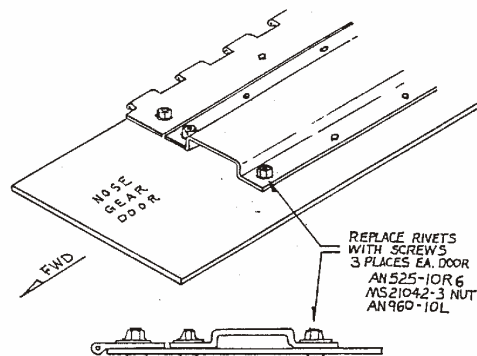
The nose gear door has a stiffener which is flush riveted onto the door skins. During one high speed descent with N106L, the rivet heads on the front row of rivets were pulled through the door skin causing one door skin to be peeled back slightly. No problem resulted other than the inconvenience associated with repairing the door. Inspection indicated that the countersinks were slightly deeper than required however based on this, we have elected to make a change.

We are changing the installation process, reference page 20-37, figure 20-G-9, to use AN525 screws along this front (former) rivet position and recommend that all customers make this same change.
