SERVICE BULLETIN

SB032-0597

Subject: All models elevator and rudder counterbalance areas

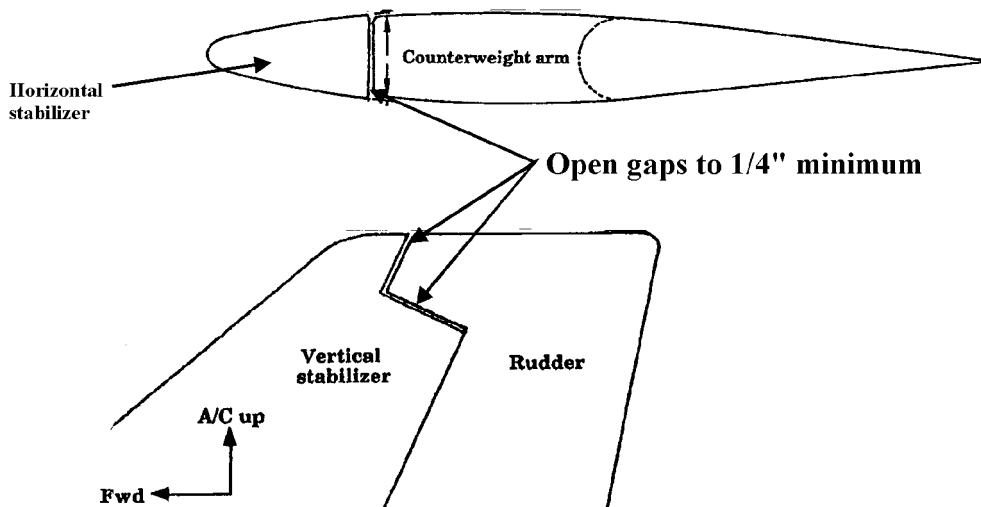
During inadvertent flight into heavy icing conditions, the build up of ice on the controls counter-balance area has caused sticking in one position.

Open up gaps to a minimum of 1/4".

Opening up the gaps and rounding the counter weight areas will allow for some more clearance. The opening of these gaps will give you a little more time to get out of the icing condition. As a reminder this A/C is not approved for flight in known icing conditions.
