SERVICE BULLETIN

SB041-1197

Subject: Lancair Control Tubes (All Lancair Models)

Date: 19 Nov., 97

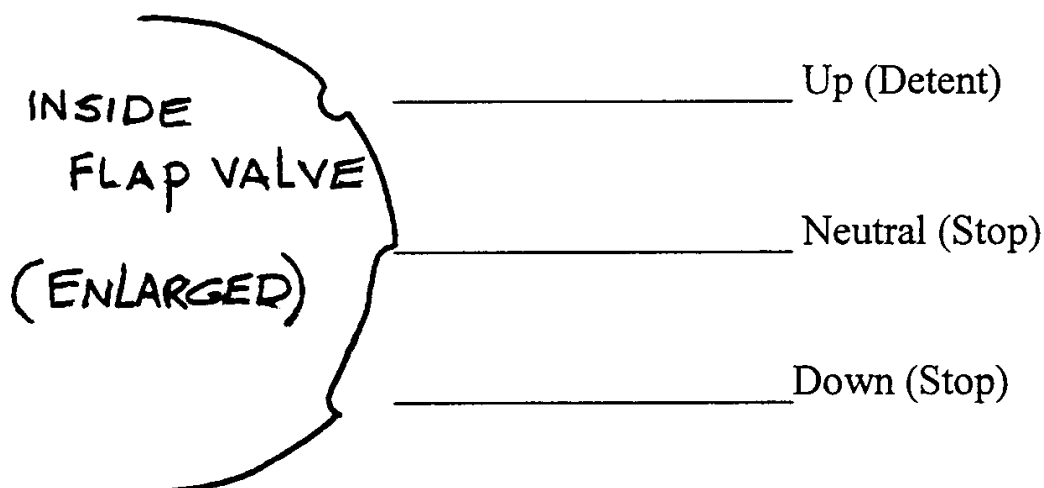
Background: This is a note regarding an incorrect valve of the flap actuator, part number 8443E-6D2PH. The flap actuator should operate with a detent in the up position, a stop in neutral and a stop (no detent) in the down position. The torsion spring that surrounds the flap actuator valve and hooks into the mounting bracket is INTENDED to spring load the flap handle from the down to neutral position.

Action: A few incorrectly detented valves marked 8443E-6D2PH have been sent out with the Lancair IV kits. These valves are detented in down and neutral positions. The correct flap actuator valve is marked 12-693-1. Check the valve in your kit for correct number and operation. If incorrect please contact Lancair so we can keep a list of customers who we need to send the correct valves to. At that time we will also give you a return authorization number to return the incorrect valve so we can return them to the manufacturer.
