**SERVICE BULLETIN**

**SB063-0602**

Subject: Legacy Lycoming 540 Engine Mount Cross Brace  
Date: June 27<sup>th</sup>, 2002  
Ref: Service Bulletin  
Pages: 2  
Status: Mandatory Compliance

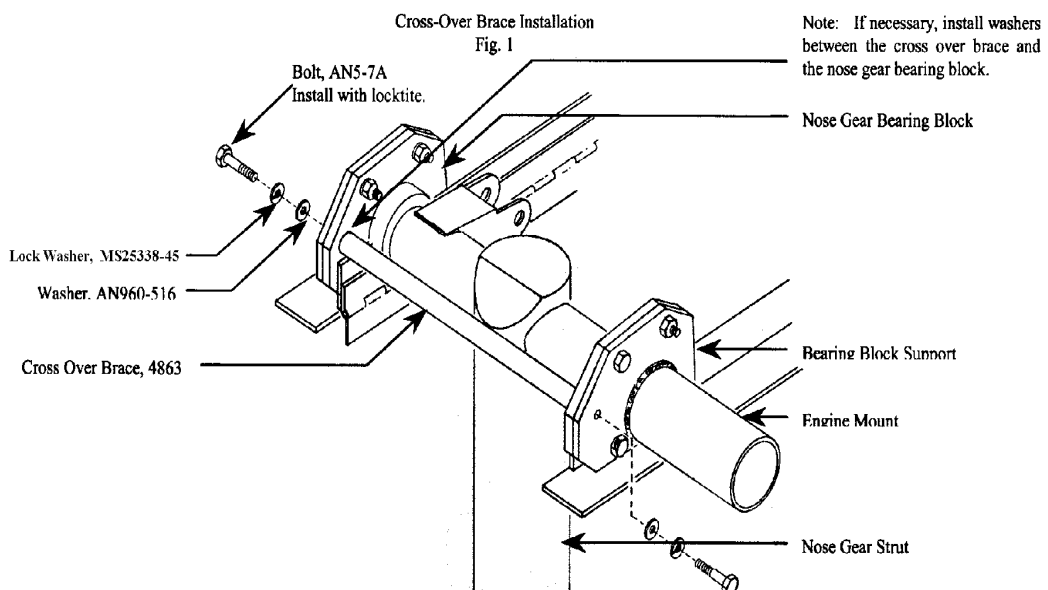
A brace is required to secure the left and right bearing block mounts. Newer engine mounts have a welded brace between the left and right bearing block supports.

Inspect your engine mount to verify whether or not the cross brace has been preinstalled. Newer engine mounts have a brace installed between the left and right bearing block supports just ahead of where the cross over brace (P/N 4863) is shown in the figure.

If your engine mount does not have a brace you will need to install a brace as shown in the figure. Please contact our parts department to get the parts kit referencing this service bulletin.

Drill a 5/16" diameter hole through the bearing block and the bearing block support. The tube is 8 3/8" long. The tube should fit nicely between the supports. If necessary, use washers for spacers between the bearing block support and the engine mount. Install the tubes with washers, lock washers, and the bolts with locktite.
